Energy Storage – Hydrogen injected into the Gas Grid via electrolysis field test

EUDP 13 – Special Pool Hydrogen

Project title	Energy Storage – Hydrogen injected into the Gas Grid via electrolysis field test
Project identification (program abbrev. and file)	Hydrogen and Fuel Cells, J.no. 1936-0004
Name of the programme which has funded the project	EUDP
Project managing company/institution (name and address)	Energinet Gas TSO A/S Tonne Kjærvej 65 Erritsø 7000 Fredericia
CVR (central business register)	39315084
Project manager and contact details	Jesper Bruun Munkegaard Hvid jbr@energinet.dk
Project partners	Energinet, Danish Gas Technology Centre, Evida, IRD Fuel Cells
Date for submission	04-05-2020

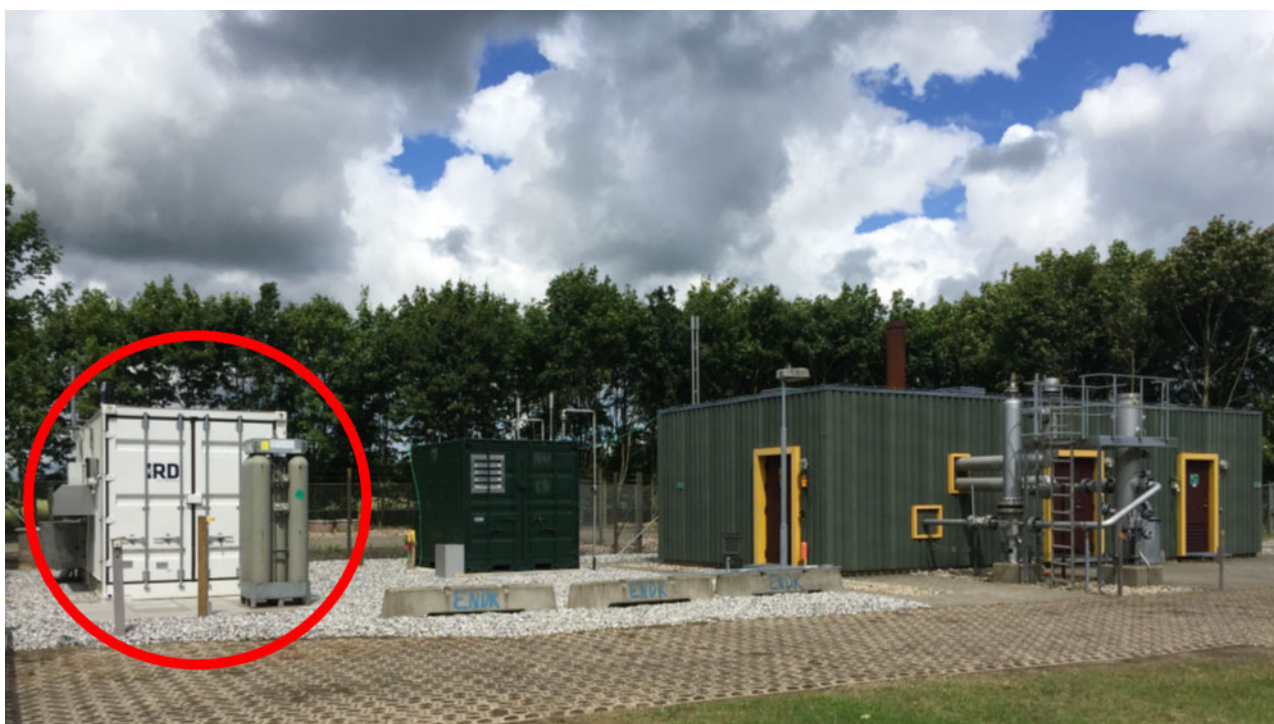
Figure 2. Hydrogen system at M/R Helle/Agerbæk.

The goal was to have an independent and stand-alone hydrogen system on-site.

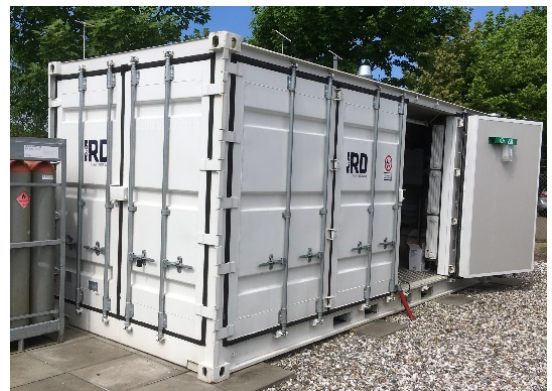
Figure 3. Insulated 20-ft container at M/R Helle in Varde.

ment was kept above 3°C by a radiator reusing the produced excess heat from the electrolyser and the μ CHP. An additional electrical heat panel was added as well ensuring reliable operation of the system.

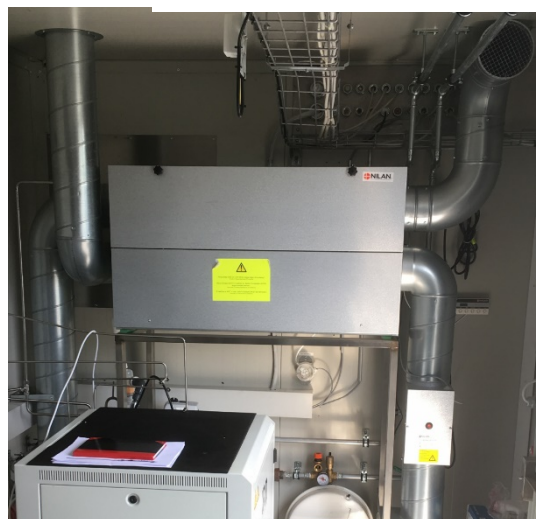
Figure 4. Ventilation system with heat exchanger installed in the 20-ft container.

The ventilation system (Figure 4) ensures first of all the inside safety of the container. The ventilation ensures that the hydrogen amount in the container cannot exceed 25% LEL⁴ which corresponds to 1% hydrogen in the air. At the same time, the ventilation system must keep down the temperature inside the container on hot summer days or reuse the heat from the air on cold winter days, by a heat exchanger.

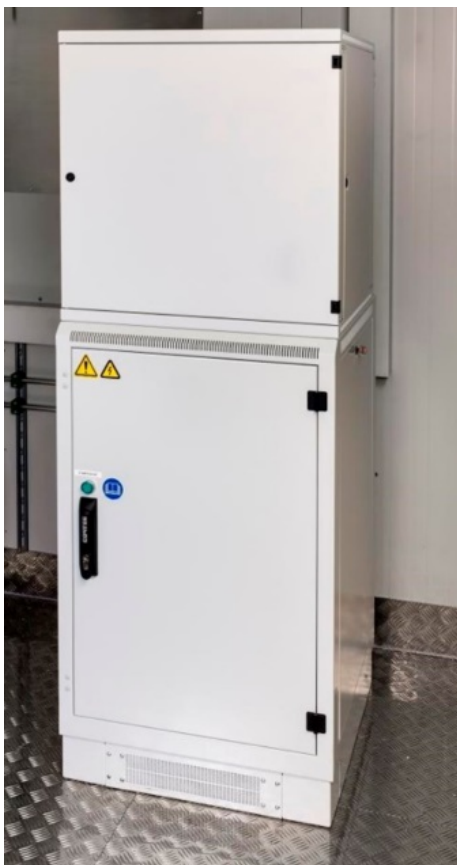
Figure 5. PEM electrolyser with drying system on top.

The power consumption of the PEM electrolyser is 5.5 kWh and of this hydrogen is produced (75%) and heat (25%). The water consumption is about 5 litres per 1 Nm³ H₂ although the theoretical water consumption is only 1 litre. The electrolyser is fed with >100 times the theoretical water amount. The produced hydrogen of the PEM electrolyser is very wet and cannot be stored in this condition. For that reason, the hydrogen passes a drying sys-

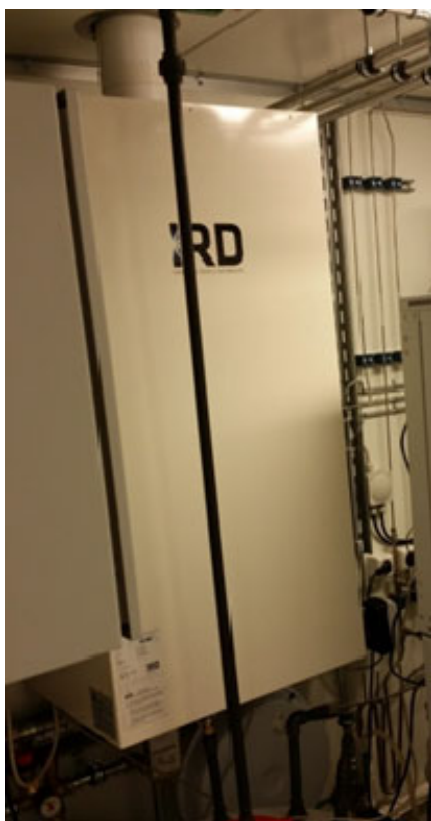
Figure 6. μCHP as wall installation.

The μCHP shown in **Fejl! Henvisningskilde ikke fundet.** has also been developed and produced by IRD Fuel Cells. The system is not directly necessary for the hydrogen production system, but it makes use of the excess hydrogen production capacity of the electrolyser and helps to achieve a longer operation time of the system and consequently more operation experience. The hydrogen consumption is $0.7\text{ Nm}^3/\text{h}$ at 0.4 barg for the μCHP , and it produces 1.5 kW pr. hour electrical power and 1.5 kW heat pr. hour. The μCHP is CE and EMC certified.

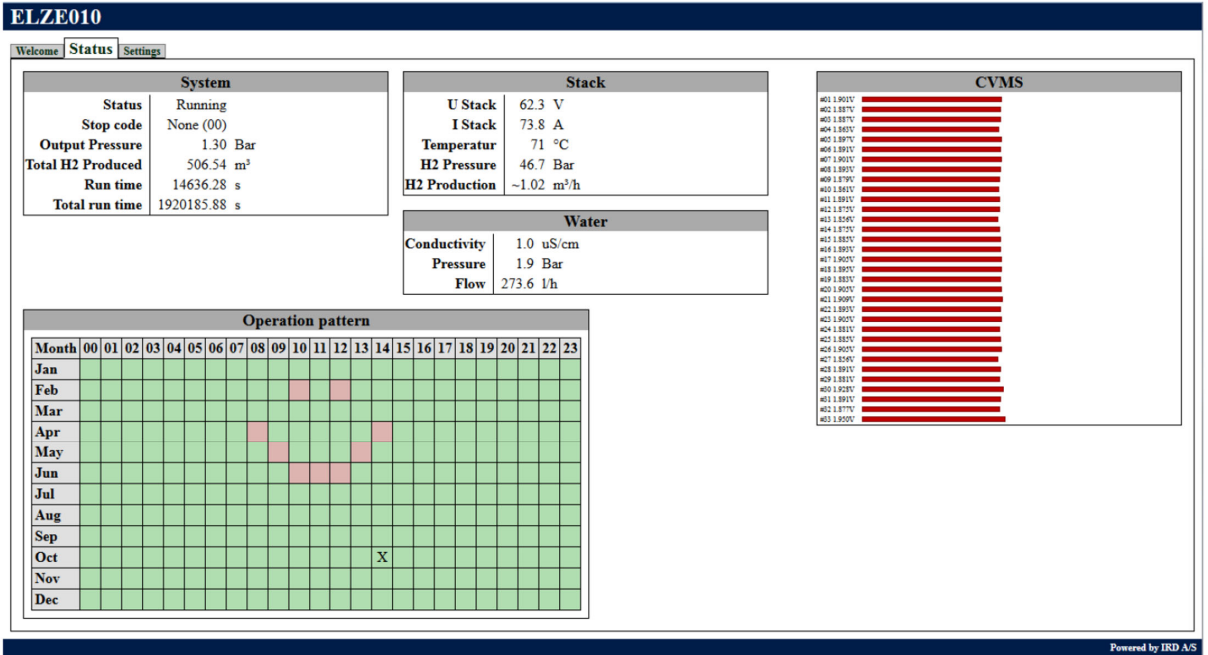
Figure 8. HMI interface for the PEM electrolyser - a web-based solution.

The HMI interfaces for the 3 systems are made in very similar ways. Here some information on the interface for the electrolyser is shown. The application is web-based, and important system information for the electrolyser stack and for the internal water system is listed. The CVMS table even shows the potential of all cells in the electrolyser stack (Figure 8).

Settings can be made for system on/off, for the stack current (min/max), and an operation time pattern can be defined for the electrolyser in the green timetable.

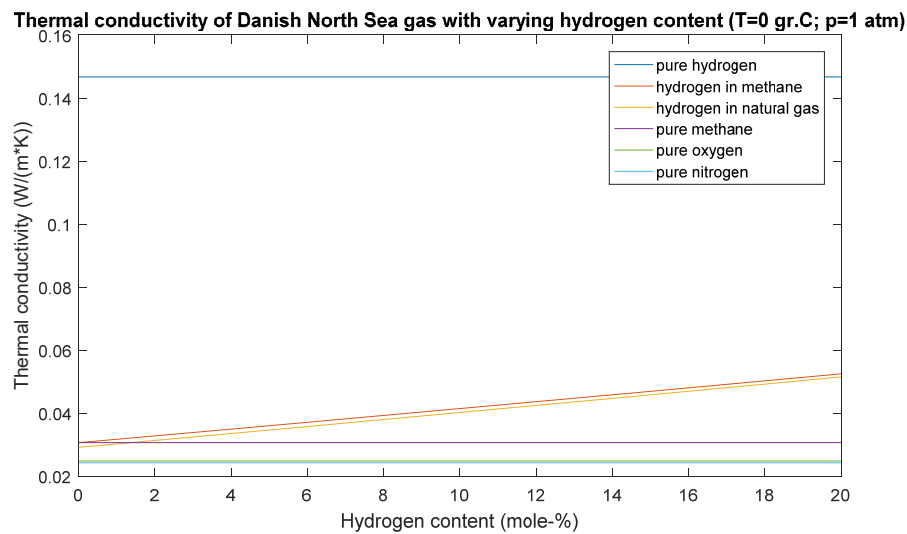
Figure 10 depicts the thermal conductivity for hydrogen in different gases and pure gas components which can be found in natural gas.

Figure 10. Thermal conductivity for hydrogen content in different gasses.

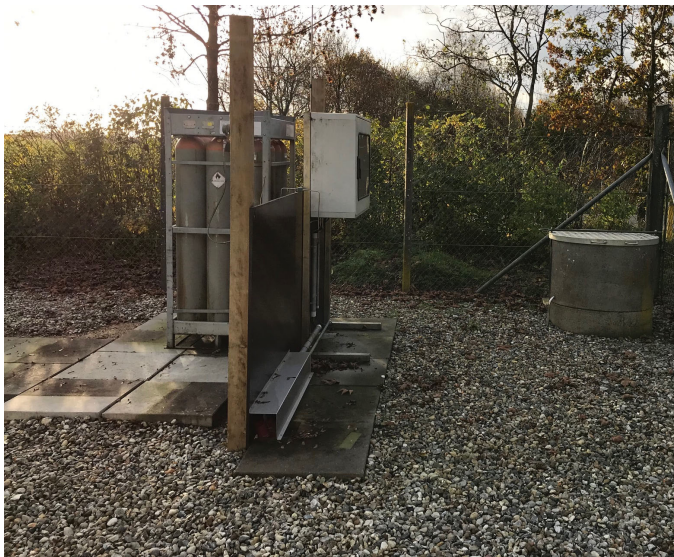
Figure 11. Picture of the hydrogen storage.

The hydrogen is delivered pressurized by Strandmøllen A/S. The hydrogen is stored at 200 bar g. The storage consists of 12 bottles with a capacity of 600 litres in total, see Figure 11.

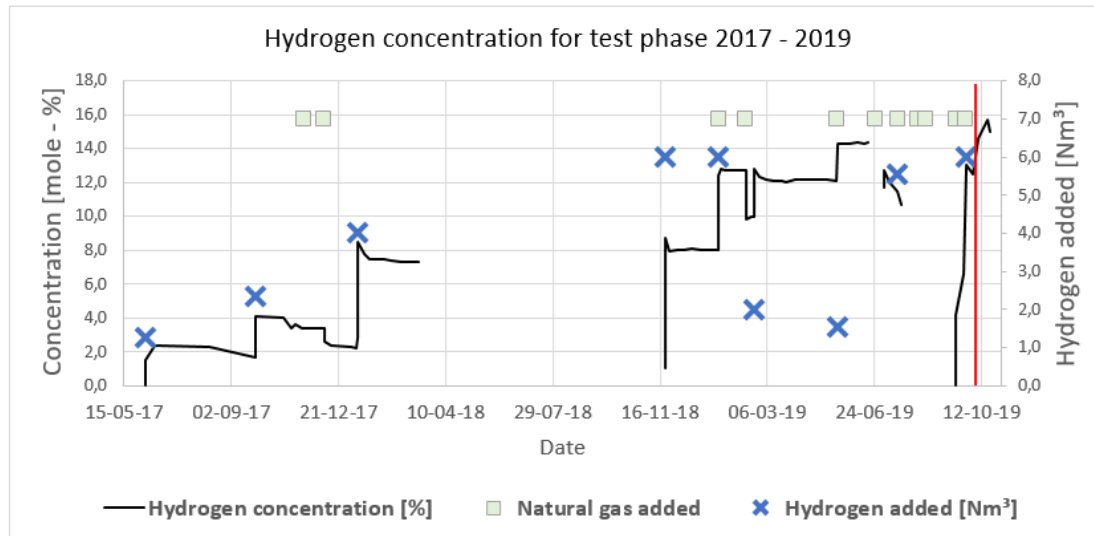
Figure 14. Overview of the test phase for the test facility.

Figure 14 depicts the concentration for the whole test phase. Each test period will be described further.

The drop in the beginning of a test period is most likely caused by the time to achieve a homogeneous mixture of hydrogen and natural gas.

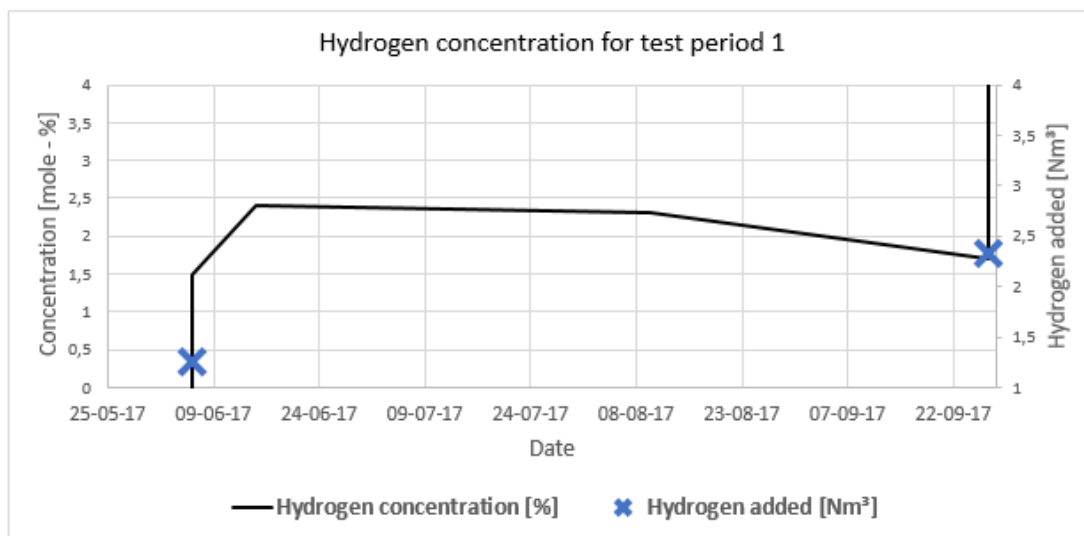
Figure 15. Result for hydrogen concentration in test period 1.

The concentration for hydrogen was kept stable for 2 months and began to decrease until the next injection of hydrogen, and a new test period.

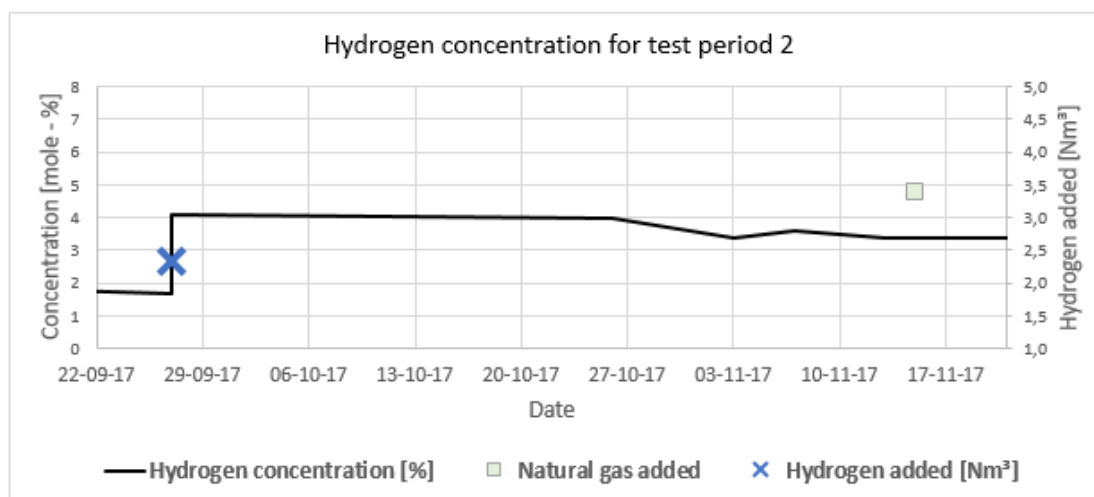
Figure 16. Specifications of hydrogen injection for test period 2.

The concentration of 4% for hydrogen was kept stable for one month and decreased to 3.4% due to blowing-off of gas in relation to a weekly check. The total decrease from the highest hydrogen concentration to the lowest was 0.6 percentage point.

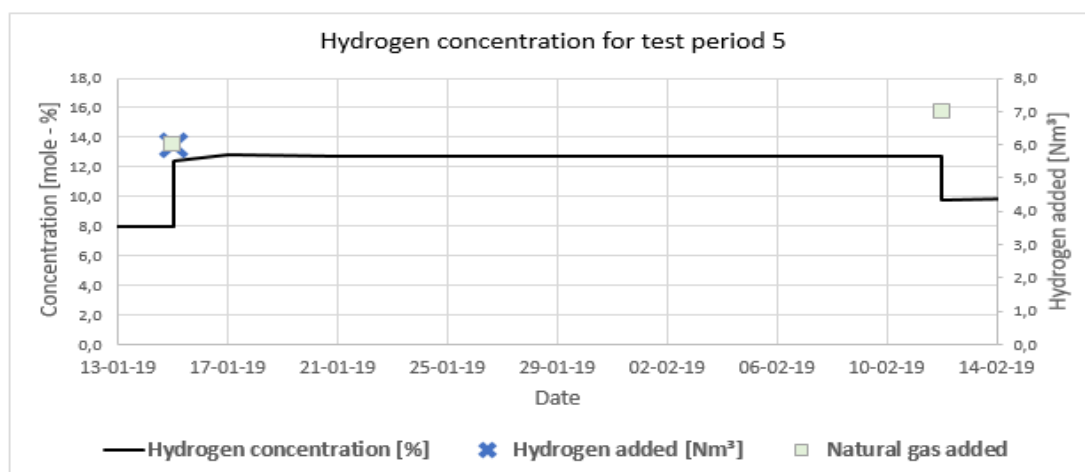
Figure 19. Specifications of hydrogen injection for test period 5.

The concentration of hydrogen was stable at 12% for about one month.

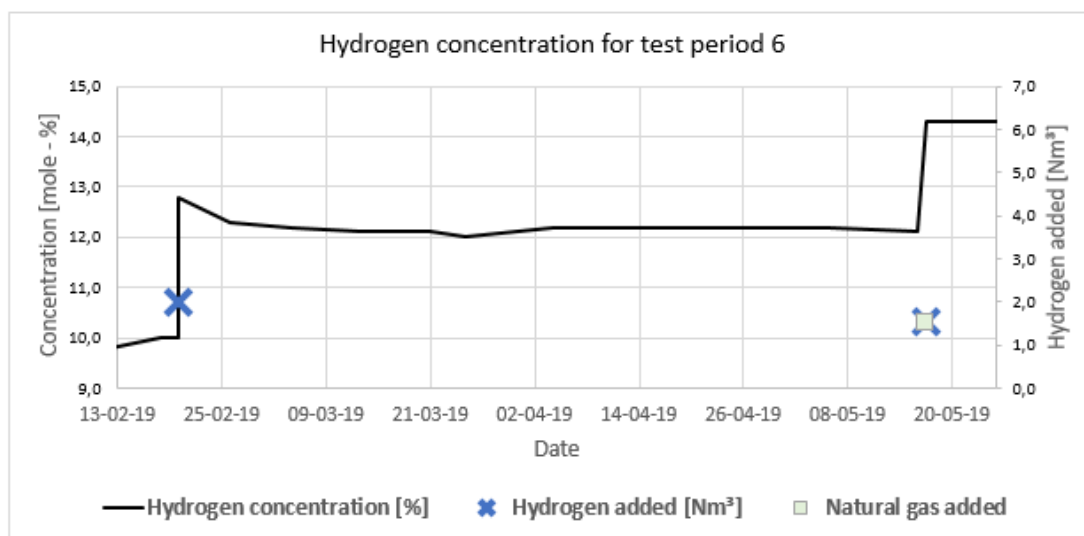
Figure 20. Specifications of hydrogen injection for test period 6.

The concentration of 12-12.1% for hydrogen was kept stable for one month.

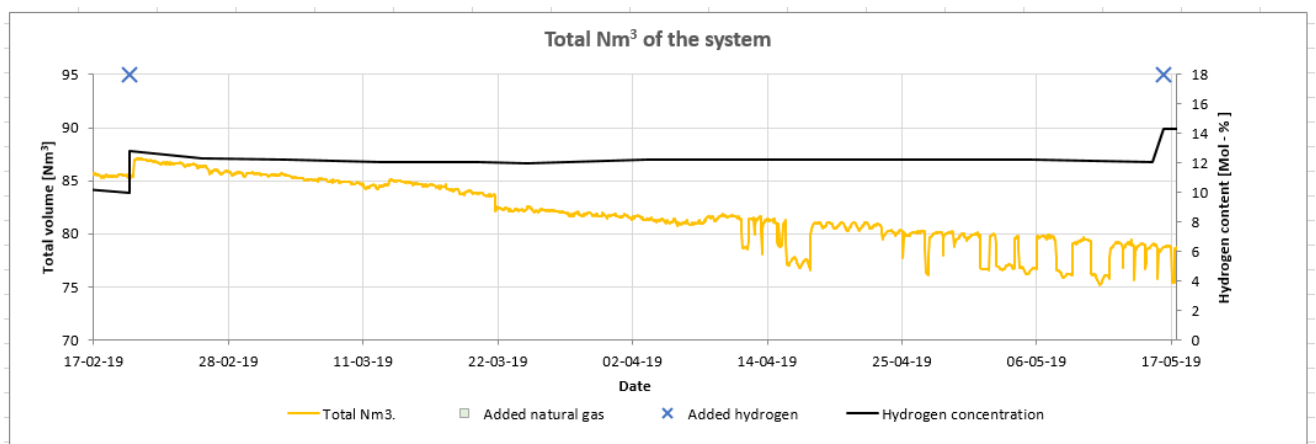
Figure 22. Total Nm³ of test facility over time for the period 20/2/19 - 17/5/19.

As can be seen from the graph, the gas volume is decreasing over the 3 months. 20th February the total normal volume is 86.02 Nm³, while at the end of the test period, 17th May, the total normal volume for the test facility is 75.36 Nm³. This resulted in a decrease of 10.66 Nm³ corresponding to 0.124 Nm³ per day. If an average flow of 1000 Nm³/h during normal operation is assumed for a plant of this size, the leakage rate corresponds to approximately 0.0005% of the transported gas.

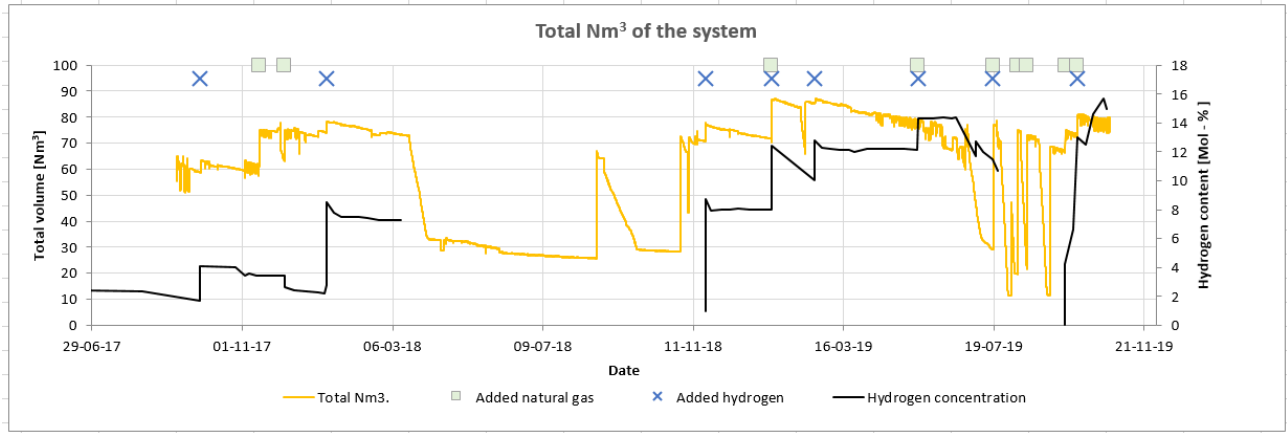
Figure 23. Total Nm³ over time for the test phase.

The analysis shows a tendency of decrease of the total normal volume [Nm³] after injection of natural gas or hydrogen in the system.

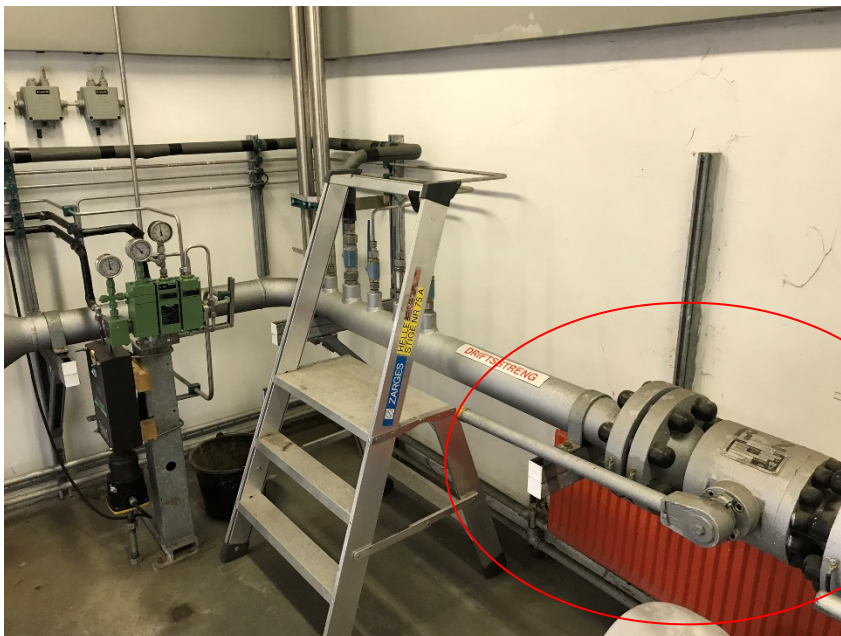
The leakage was related to a Trunnion ball valve on flow string one, see Figure 24, and was found manually during a weekly check the 6/8/19. The valve was replaced at site shortly after the fault detection.

Figure 24. Picture of the leaking valve in M/R Helle.

The hydrogen concentration was decreasing, which indicated a heterogenous leak of the mixture. The valve was diagnosed further, to determine if the leakages were related to hydrogen or not. The result of the inspection indicated that the reason for the leakage was a teared O-ring at the grip of the valve.

The conclusion of the inspection was that the fault was not related to hydrogen. Furthermore, was it concluded that the condition of the valve was fine, and a replacement of the O-ring would prevent homogenous and heterogenous leaks.

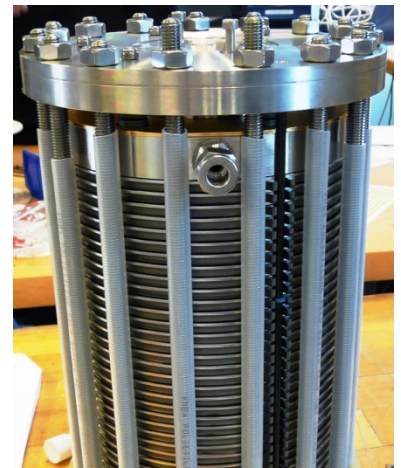
Figure 25. The IRD PEM stack with 33 cells.

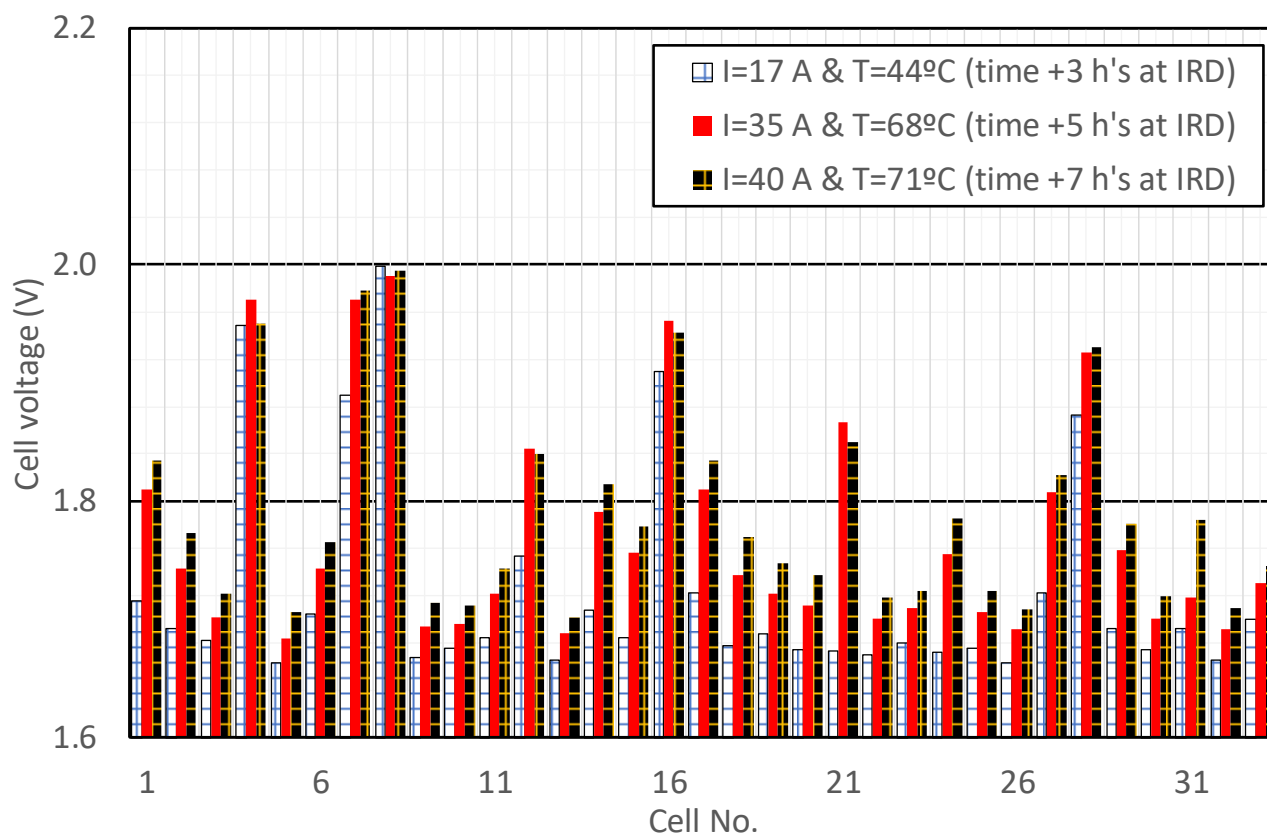
Figure 26. Test of the PEM electrolysis stack that was located at the M/R station Helle for more than 3 years. Individual cells are not allowed to exceed a voltage above 2 V, which means that the lowest common cell performances denominate the stack current. As examples, cell 7 and 8 are performing poorly, and cell 9 and 10 are performing well.

A test series at three different temperatures was performed. It was not possible to run the stack at 70 A nominal. The stack current could not exceed 40 A in the first test, and in the second and third tests the performance went even worse. Figure 26 shows the cell voltages in dependency on current and temperature. As the cell voltage must not exceed 2 V, a few poor performing cells denominate the current. Examples of poor performing cells are cell 7 and 8, the ones showing the highest voltage.

According to the test results in Figure 26 we assume that the long idle time had a degenerative effect on the stack and its cells and assumable the membranes. In the following, a few standard tests of MEAs of the specific stack are described to evaluate the MEA condition.

Analysis of MEAs from selected cells of the stack: As shown in Figure 26, the cells in the PEM stack of the electrolyser at Varde, performed very differently. A standardized single cell test for MEAs was accomplished for a well performing membrane of cell 9 and a poor performing membrane of cell 7. The test cycle is shown in Figure 27 for cell 9 and in Figure 28 for cell 7. The MEAs were carefully removed from the electrolyser cells, and a standardized area was cut from each. Due to the long idle state at the M/R station the PFSA (Nafion) membrane was rather fragile. These two MEA samples were used in the shown standard test in Figure 27 and Figure 28. On top of the two MEAs from cell 7 and 9, a further three MEAs were single cell tested, but quickly developed crossover due to fragile membranes and the tests could not be continued. The test results for these three MEAs is not shown and not further discussed.

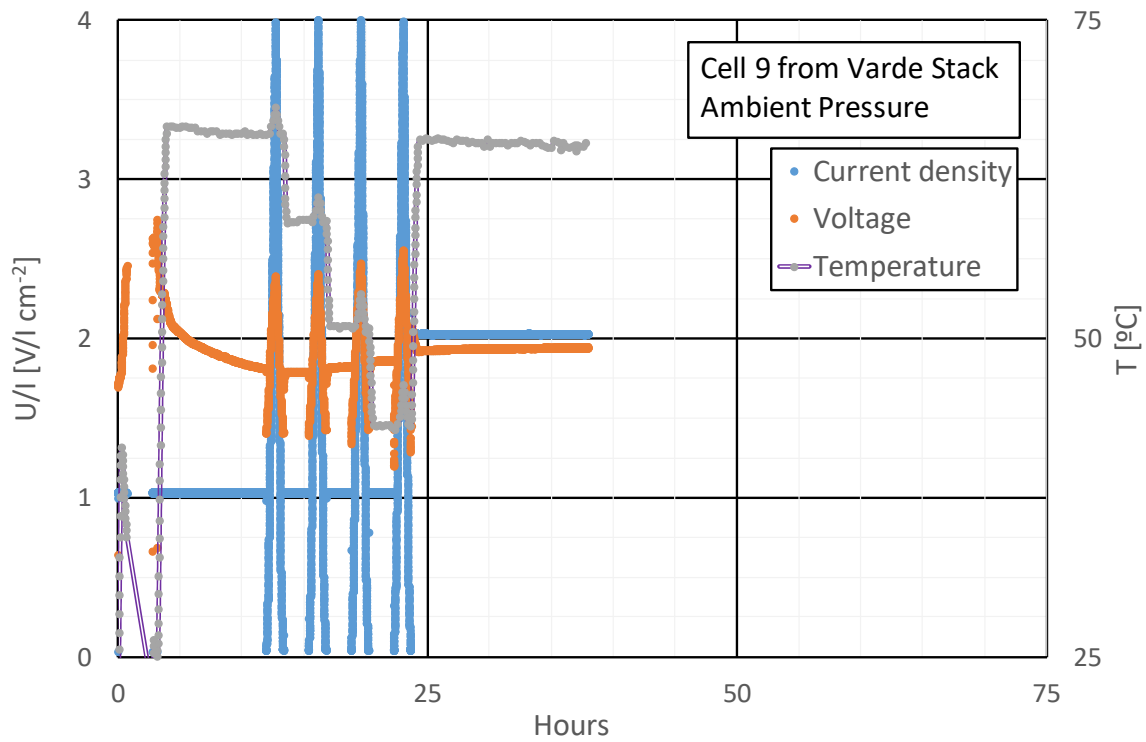
Figure 27. Overview of test of single cell from electrolyser stack - here the EoL test (End of Life) of the membrane of cell 9 (see Figure 26), a well performing membrane.

Each test was performed at 4 different temperatures, and the voltage was limited to 2V for long term run. The test system tries to optimize the current shown in A/cm² (current density) at the defined temperature and at max. 2V. The best performance is expected at higher temperatures at around 70°C.

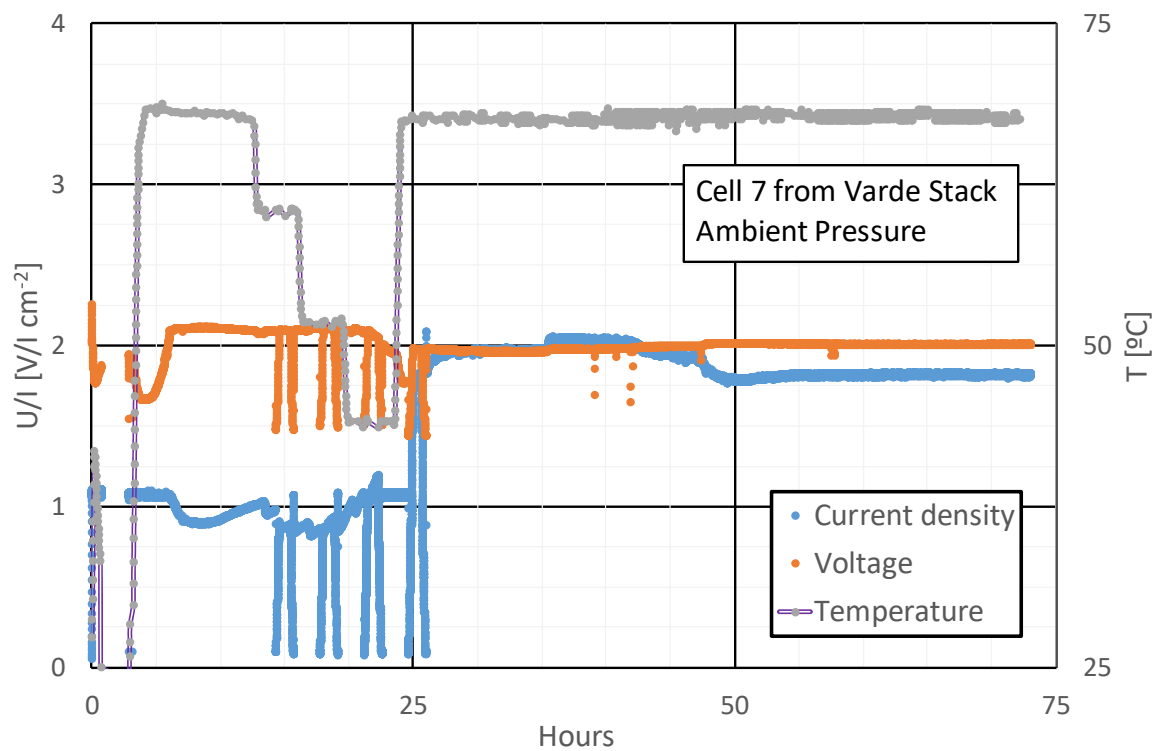
Figure 28. Overview of test of single cell from electrolyser stack - here the EoL (End of Life) test of the membrane of cell 7 (see Figure 26), a poor performing membrane.

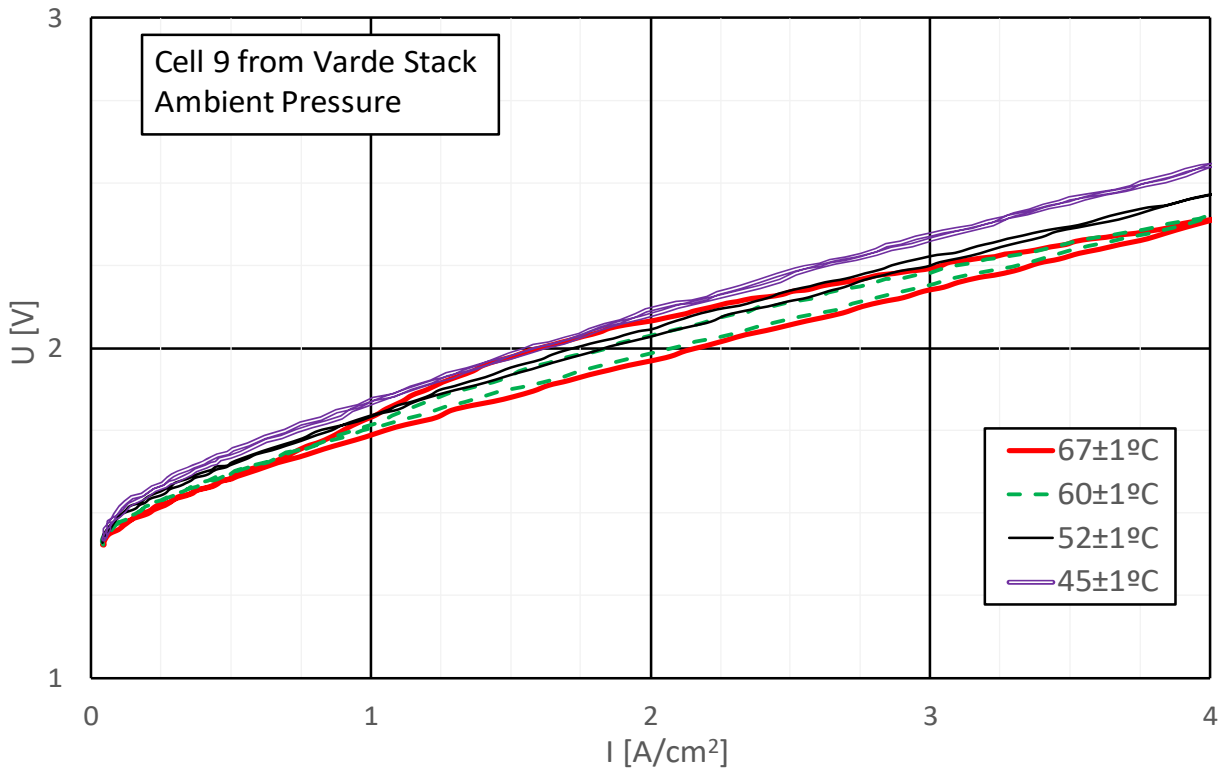
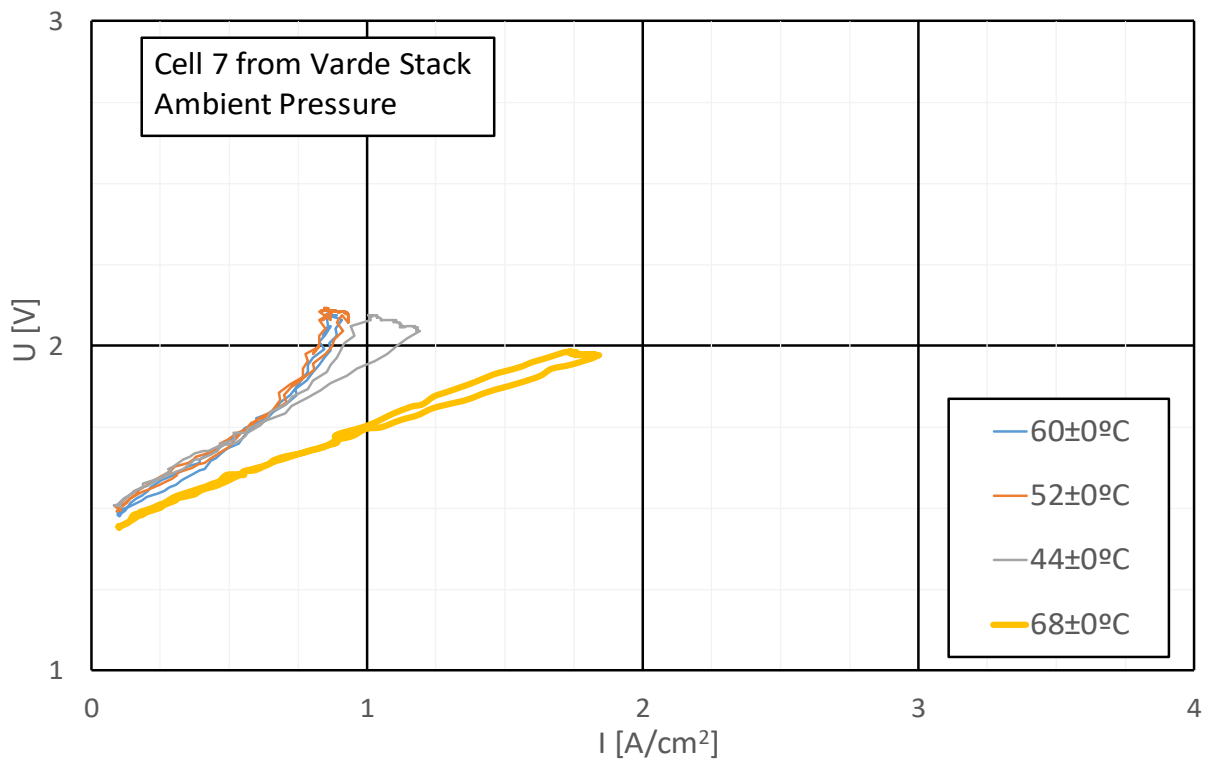
Figure 29. Single cell performance test of two selected cells from the electrolyser stack. A) Cell 9, which performed well in the preliminary EoL test at IRD cf. Figure 26. B) Cell 7, which performed poorly in the preliminary EoL test at IRD cf. Figure 26.

In Figure 29 the performance results are shown for cell 9 (good performance in preliminary test) and cell 7 (poor performance in preliminary test). The higher the current density per voltage is, the better the cell performs. The test set-up for cell 9 is a newer version than the set-up for cell 7, and the newer version can run sample tests over a wider U/I range (see Figure 29 for cell 9).

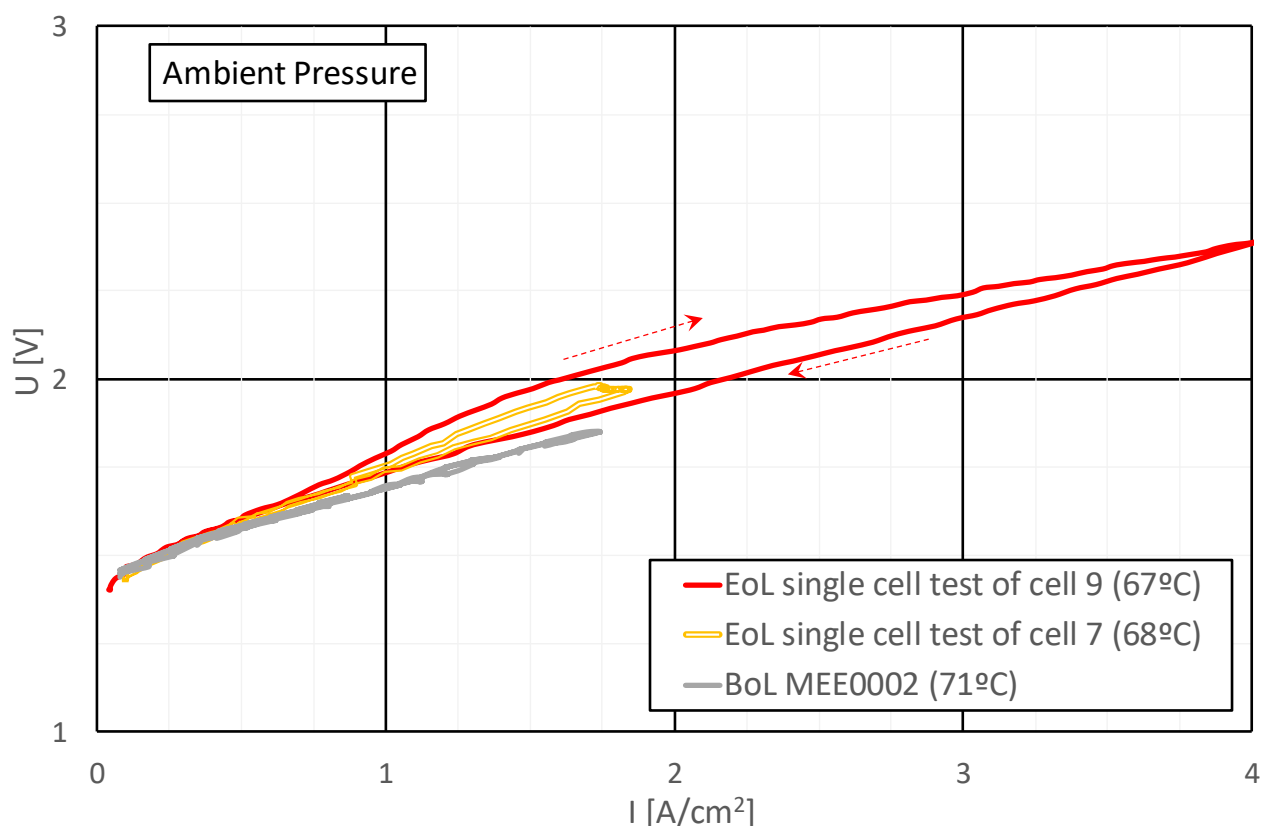
Figure 30. Comparison between BoL⁹ performance in the IRD single cell test stand, the EoL cell 9 performance and the EoL cell 7 performance.

The performance differences between the EoL test of cell 9 and 7 are actually limited and it is more clearly illustrated in Figure 30, where a standard test of a new membrane of the same Nafion material has been added to the Fig.s of cell 9 and 7 for comparison reasons.

Figure 30 shows the performance of the three membranes in the single cell test, EoL of cell membrane 9, EoL of cell membrane 7 and BoL of the new membrane. The comparison shows the following:
