# Slutrapport

Energistyrelsen-EUDP 14-II

## Demonstration af kombineret solcelle- og solfangermodul (PVT) til etageboliger Fase II

*Oktobre 2017*

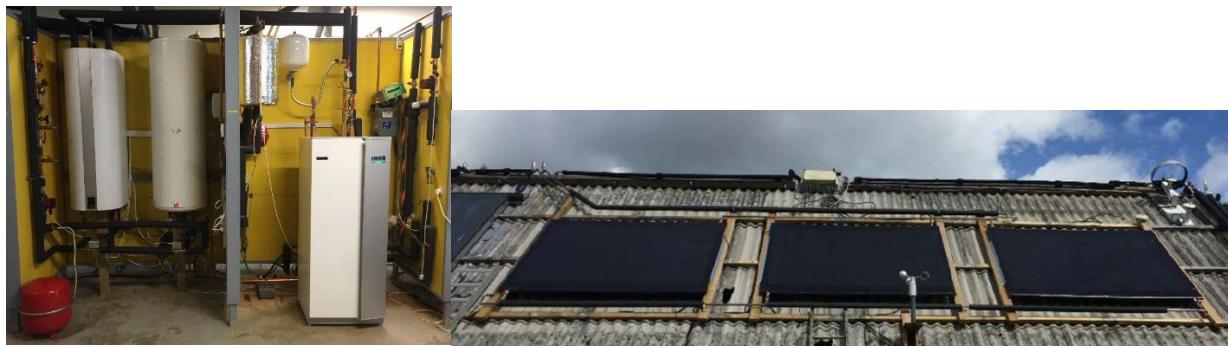
Figur 1 Forsøgsopstilling på DTU. Til venstre beholdere og varmepumpe. Til højre de 3 PVT-E moduler.

På DTU var der opbygget et nyudviklet regulerbart saltanlæg, der præcist og dynamisk kunne simulere forbrugsprofilen fra de data der var blevet indsamlet fra etageejendommen på Nørrebrogade. Da der tilmed på DTU ikke var begrænsninger ift. fjernvarmeselskab, blev det besluttet at man uddover at undersøge budraget fra traditionel solvarme til varmt vand, på anlægget på DTU også skulle medtage demonstration af PVT med en tilkoblet varmepumpe for at øge fleksibiliteten og udnyttelsen. Med varmepumpen blev der åbnet for at man også kunne måle, analysere og vurdere mulighederne for BIPVT i områder i Danmark, hvor der ikke er adgang til fjernvarme. Således kunne demonstrationen på DTU eftervise hvorvidt man uddover produktion af varmt brugsvand også kunne producere rumvarme i rigelige mængder.

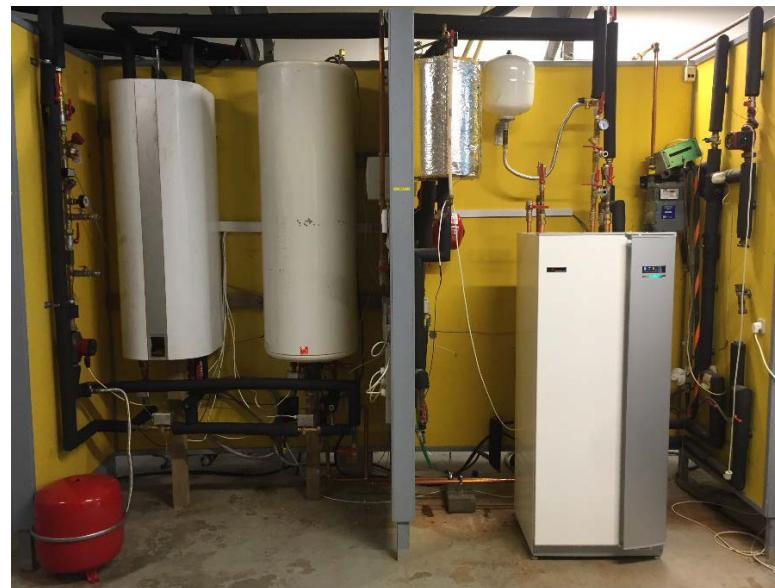
Figur 9. Indoor installation of two storage tanks and a liquid/water heat pump.

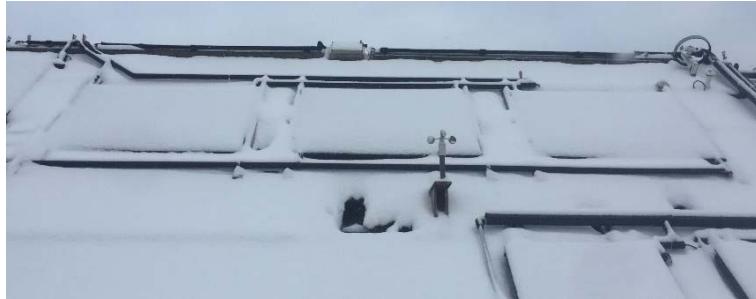
On the 9/2/16 there was 10-15 cm snowfall on the PVT collectors (Figur 21).

**Figur 21.** Snowfall on collectors 9/2/17 at 10:21

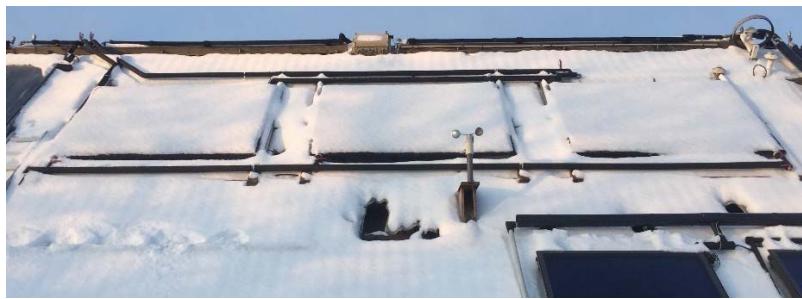
On the 10/2/16 there was little solar irradiance. Snow sled off thermal collector below PVT collectors and remained on PVT collectors (Figur 22).

**Figur 22.** Low level irradiance 10/2/17 at 16:14

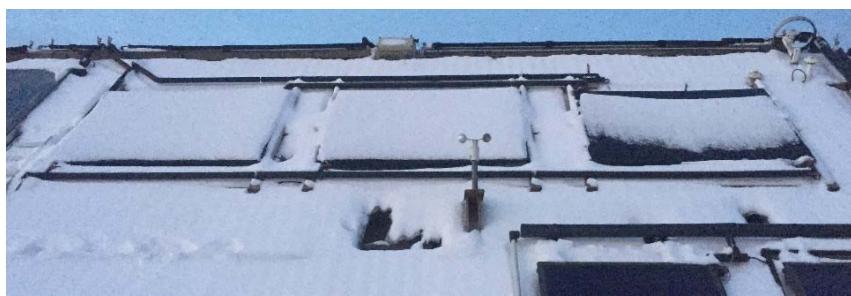
**Figur 24.** Snow partly melted on right PVT collector at 17:34 on 10/2/17.

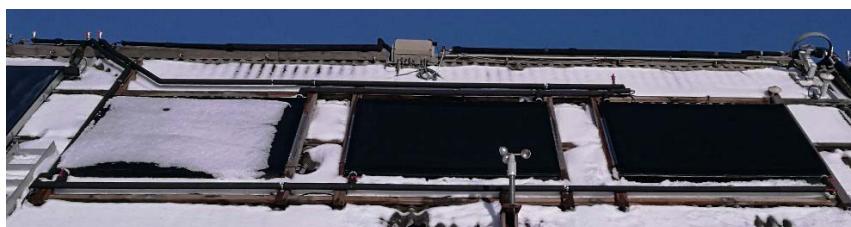
valves to the middle and right PVT. After a DHW discharge at 7:30 the heat pump recharged the DHW tank while discharging the cold tank down to a temperature of  $-7^{\circ}\text{C}$  (Figur 25). The ambient temperature ( $\text{Ta}$ ) was around  $0^{\circ}\text{C}$  and the collector loop started to run (F1). There was sunny sky (G<sub>total</sub>) and the snow on the middle PVT melted off rapidly, while the snow in the left PVT remained due to the heat transfer fluid circulated in the loop (T2) was below  $0^{\circ}\text{C}$  (Figur 26).

**Figur 26.** Left PVT covered with snow at 11:06 on 11/2/17.

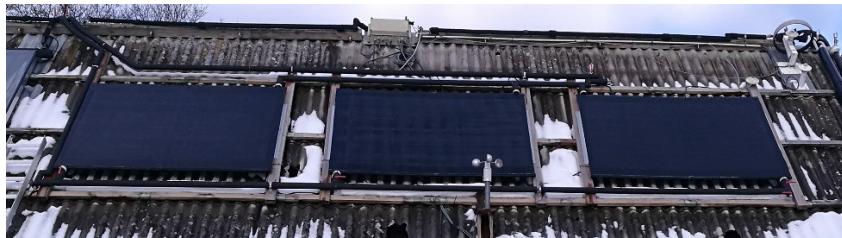
**Figur 28. PVT collectors 11/2/16 at 12:50**

From the investigated case, it was found that the operation strategy of the PVT system hindered the snow to melt off fast as the cold heat transfer fluid in the loop cooled down the snow on the collector. The snow on the collector without active thermal loop melted faster. When the PVT panels were covered with snow and the temperature of the cold tank was below 0 °C allowing the snow to melt off before starting the collector loop pump would have led to a higher output over the day.
